Warner's Pond Watershed Management Plan

Warner's Pond
Concord, Massachusetts

ESS Project No. C574-000

Revised May 25, 2012

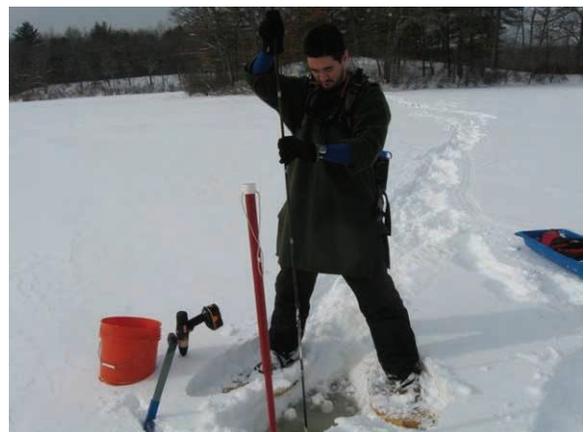
Extending tile probe into sediment to measure depth.

The pond was covered in approximately 16 inches of ice during the time of the survey. A datum measurement was taken at the pond outlet with water surface 5.5 feet below the top of the concrete spillway. Using maps and a DGPS, ESS navigated to each sampling station and used an ice chipper and battery-powered drill to create a hole through the ice. An extendible carbon steel tile probe was extended through the hole to collect two measurements: water depth and total depth. Total depth was obtained by pushing the tile probe into soft sediments until "refusal" at a harder underlying substrate was reached. Data was recorded in field notebooks and used to create figures using a GIS.

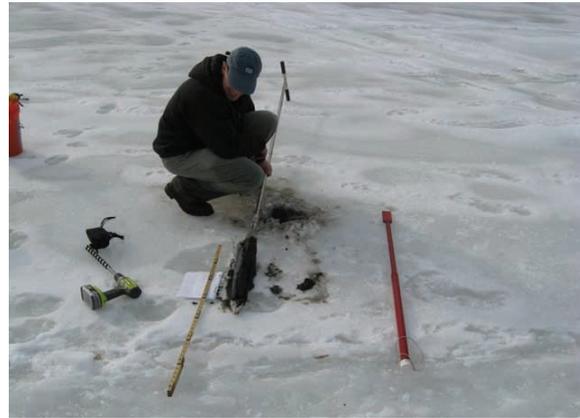
View of a sediment core extracted with the peat corer.

An initial round of sediment sampling at Warner's Pond was completed on February 17, 2011. Prior to collecting sediment, the locations of 12 sediment core locations were plotted using GIS (Figure 4). The coordinates of the 12 sediment core locations were uploaded to a DGPS to navigate to locations in the field. The sediment core locations were selected to characterize the areas of Warner's Pond that are under consideration for dredging and to evaluate any effect of the former landfill at the southwestern corner of the pond on sediment quality. Sample sediment cores were recovered from the pond bottom using an extendible Russian peat corer. ESS photographed each sediment core (Attachment B) and characterized the core color and texture.

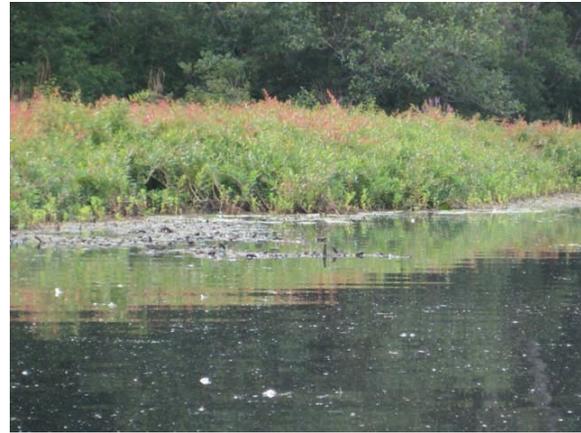
View of scrub-shrub wetlands that fringe large areas of Warner's Pond. Water willow is dominant.

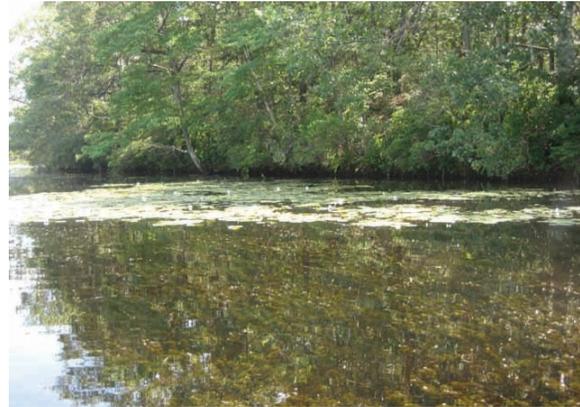
Dense aquatic plant growth just south of Scout Island. Fanwort is visible just below the water surface.

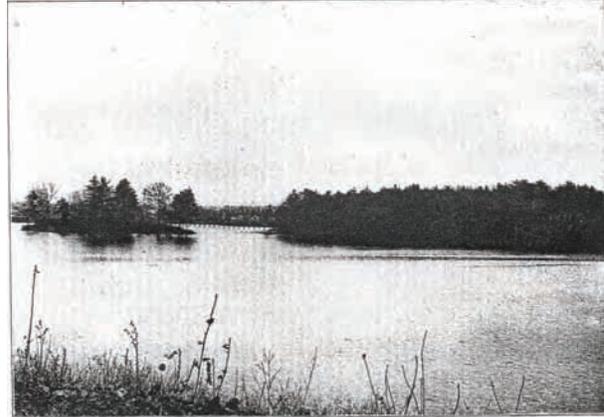
Historic photo of Scout Island. A bridge that once ran to the island is just visible in background.

In the 1890s, a bridge connected the mainland with Scout Island (then the Isle of Pines), the largest island in the pond. At this time, the Isle of Pines was subdivided into 34 lots for summer cottages. In 1944, ownership of the island was transferred to the Boy Scouts Troop 33 of West Concord and, owing to the use of the island by Boy and Girl Scouts for camping, nature study, cooking and sports, it eventually became known as Scout Island.

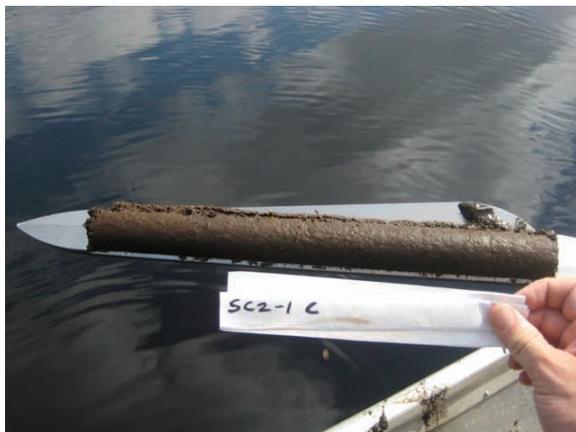
Sediment core sample from Warner's Pond.

The color and texture of each sediment core collected was documented during the sampling effort. In addition, each sediment core was photographed (Attachment B). The majority of the sediment cores collected consisted of a dark brown, organic muck mixed with silt. A few of the sediment cores were dark, brown, organic mucks mixed with greater percentages of sand and clay. Refusal during sediment core collection was reached at either an underlying sand or clay layer.

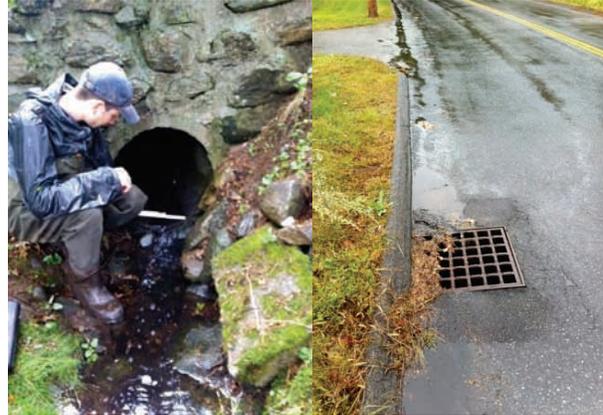
Measuring flow from outfall and stormwater discharging to a catch basin on Wright Road during wet weather sampling.

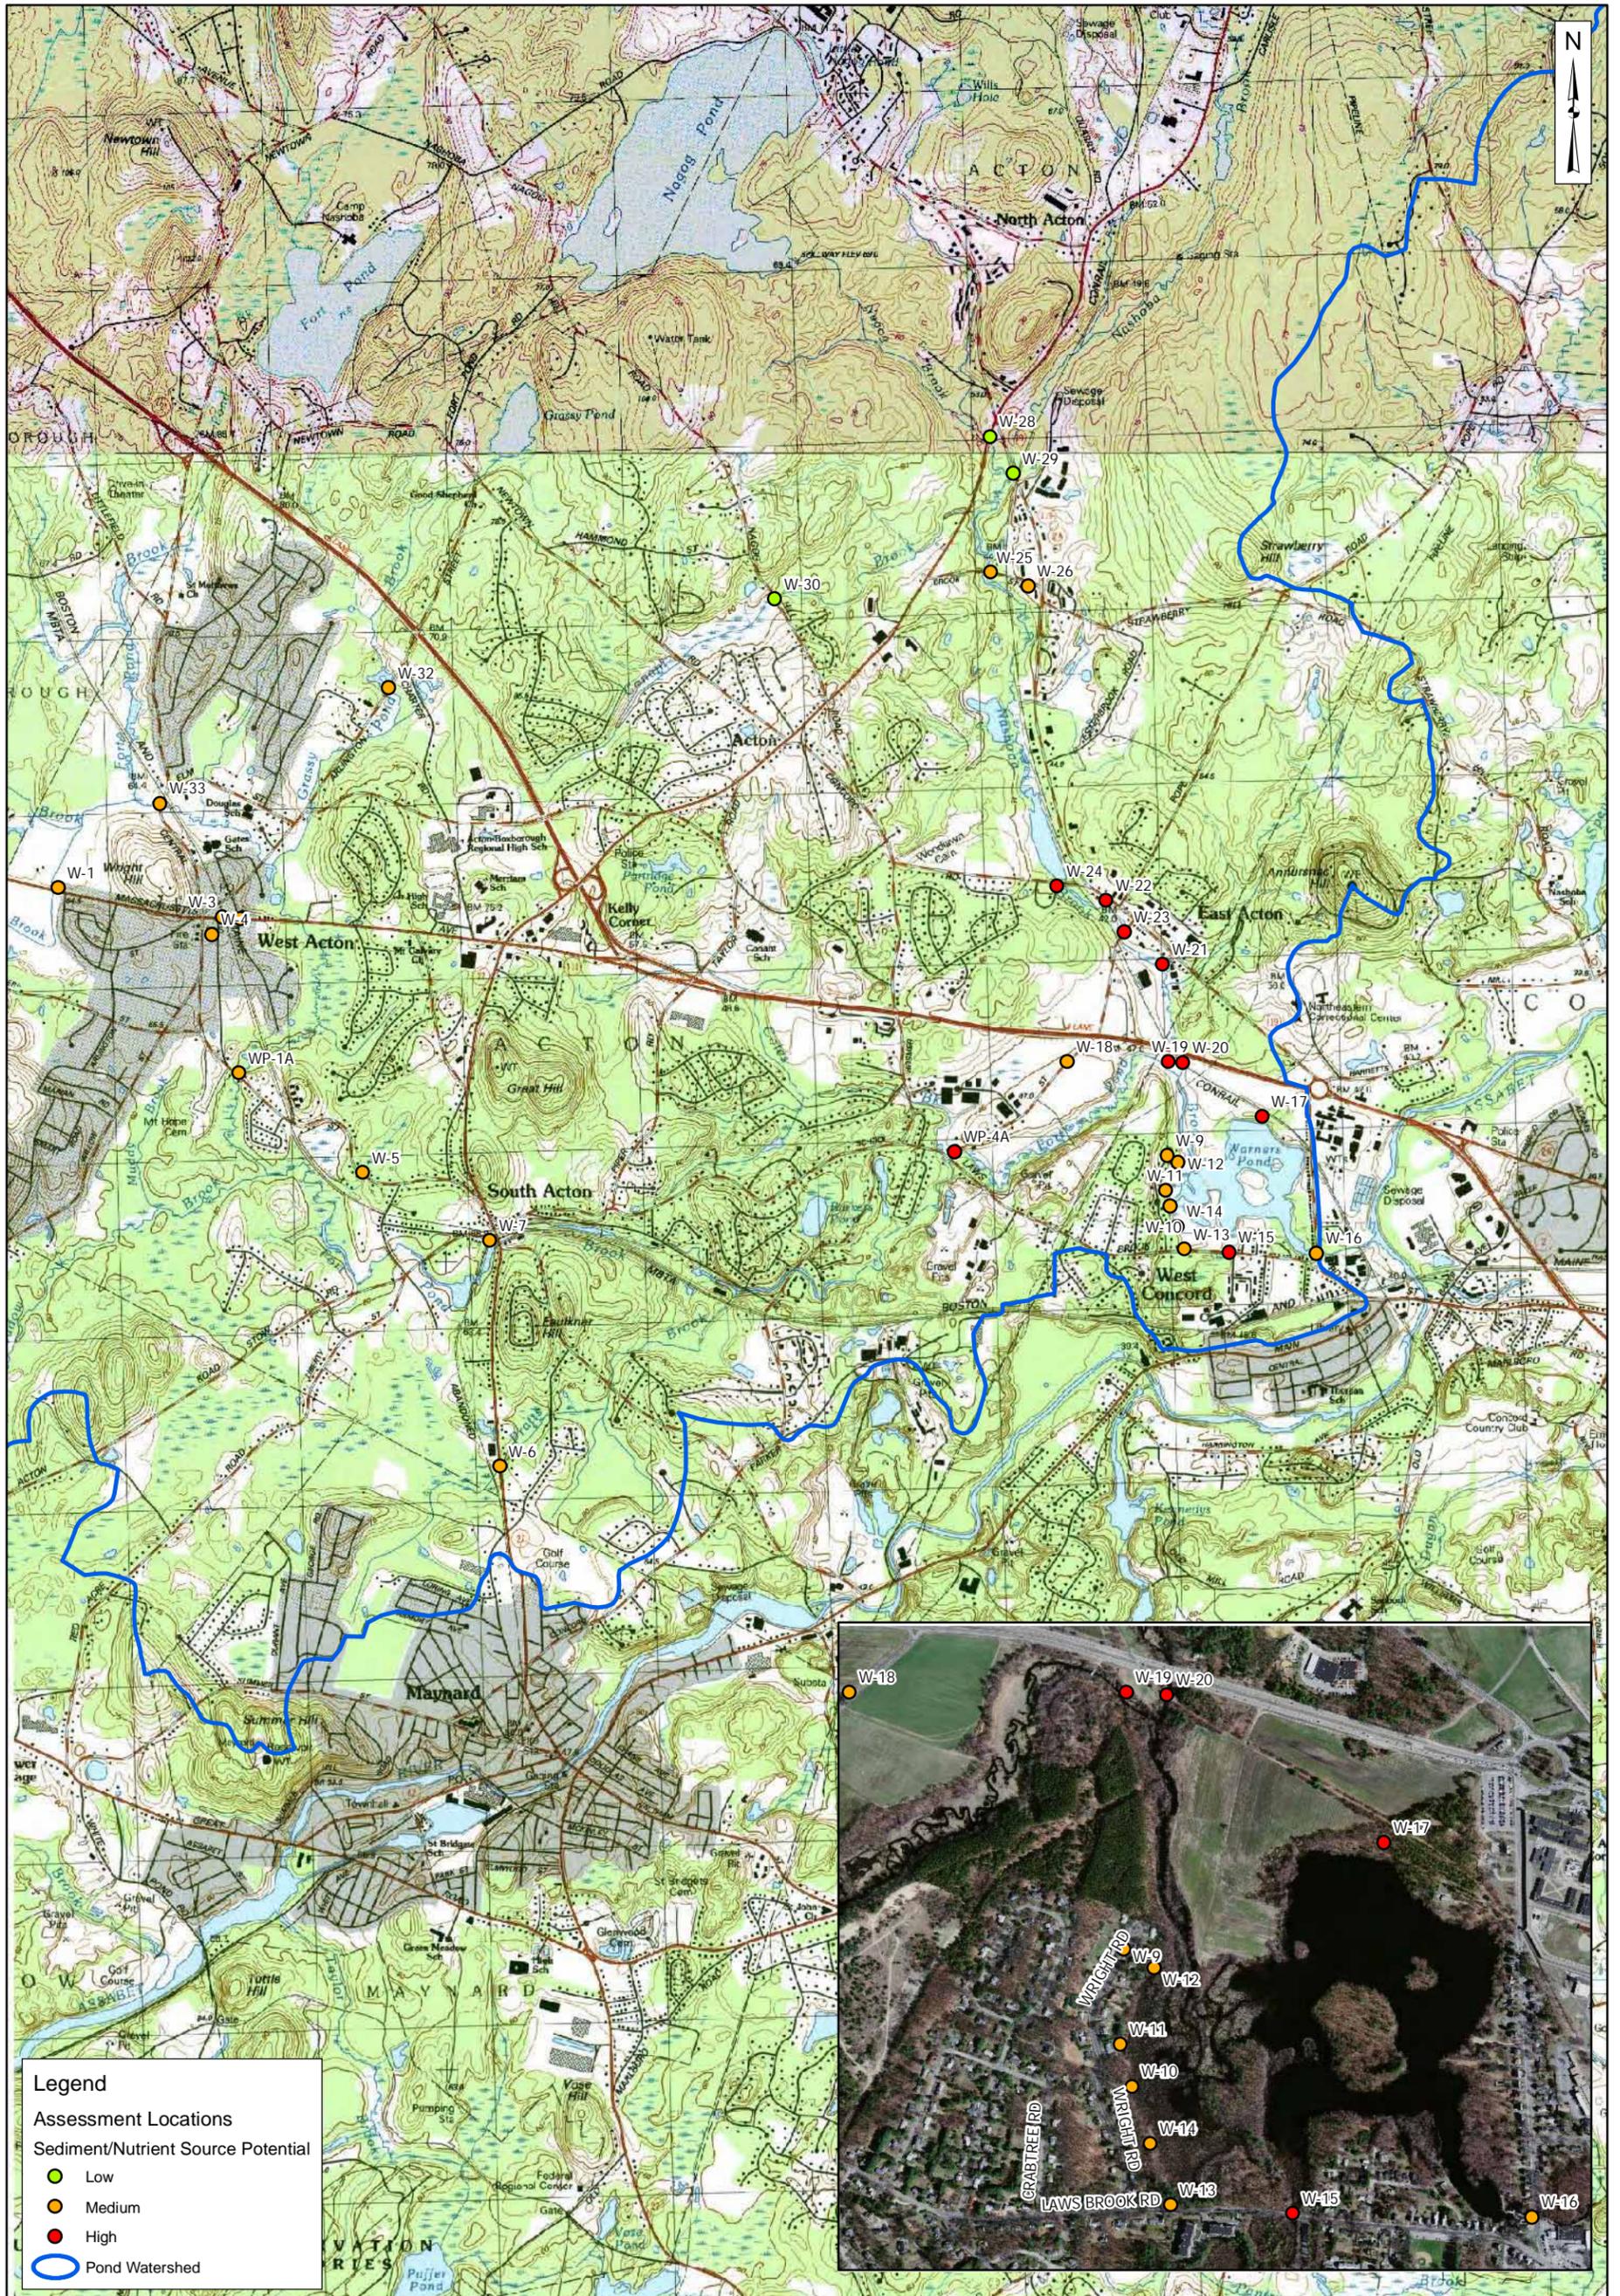
Watershed Assessment Results

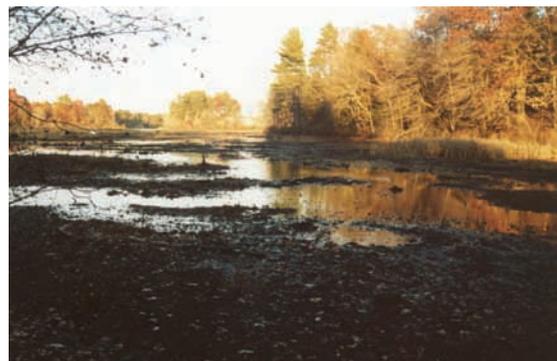
Drawdown involves lowering the water level of a pond to expose shallow bottom sediments and associated plants (both native and non-native) to drying and/or freezing. It is most effective against species that reproduce mainly by vegetative means, including fanwort and variable watermilfoil. Drawdown is less effective on species that reproduce primarily by seed (such as the invasive exotic species water chestnut and curly-leaf pondweed) and may expand beds of these species. Under some circumstances, drawdown may also encourage the spread of purple loosestrife in hydrologically connected wetlands. In Warner's Pond, this would primarily be a concern in the water willow dominated wetlands on the western margin of the pond, where purple loosestrife is already present.

Ponds with rapid drop-offs to great depths tend to benefit most from drawdown. Due to the shallow bathymetry of much of Warner's Pond, drawdown is only likely to provide limited control of aquatic invasive plant growth. Although drawdown can be conducted at any time, the interaction of drying and freezing that occurs with winter drawdown is usually most effective. Environmental restrictions and recreational uses also limit the appropriate window for drawdown to the winter period. In Massachusetts, winters are often variable in their intensity and the ideal winter condition of very cold weather with limited snow cover (which insulates the plants) is not likely to be achieved any more frequently than every other year.

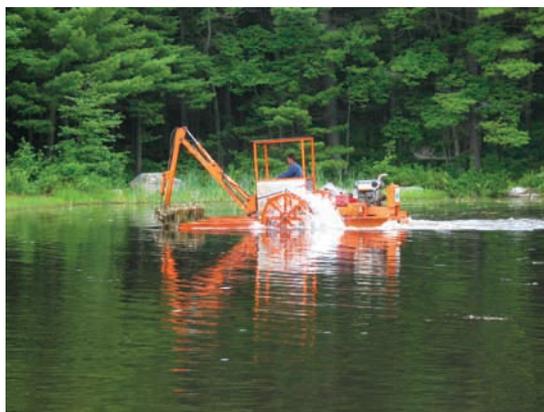
Hydroraking uses a backhoe-like machine mounted on a barge to remove plants directly from pond sediments. Depending on the attachment used, plants are scooped, scraped, or raked from the bottom and deposited on shore for disposal. Rotovation is essentially underwater rototilling of pond sediments. Rotating blades cut through roots, shoots, and tubers, dislodging and expelling them from their growing locations. Some operations are also outfitted to collect some or most of the rotovated plant materials. Both hydroraking and rotovation are most useful for local control of water lilies and other plants with large rhizomes or tubers, as these methods can physically remove or destroy the bulky portions of the plant.

Hydroraking has been previously attempted at Warner's Pond. It proved to be an effective approach at managing water lilies in selected areas but would not be recommended against vegetatively reproducing species such as milfoil and fanwort. The primary disadvantage of hydroraking and rotovation is that they spread invasive plants that reproduce via vegetative fragmentation. However, this is not currently a major deterrent in Warner's Pond due to the fact that variable watermilfoil and fanwort appear to have colonized all available habitats in the pond. Fragment barriers could be deployed around management areas prior to hydroraking or rotovation to reduce escape of vegetative fragments. If dredging proves to be too costly to implement in the near term, continuing with a hydroraking program within the targeted management zone (Figure 14) may be an appropriate alternative to maintaining some open water habitat within the pond. Costs to perform hydroraking vary depending upon a number of factors, but based on first hand experience at this pond previously it is

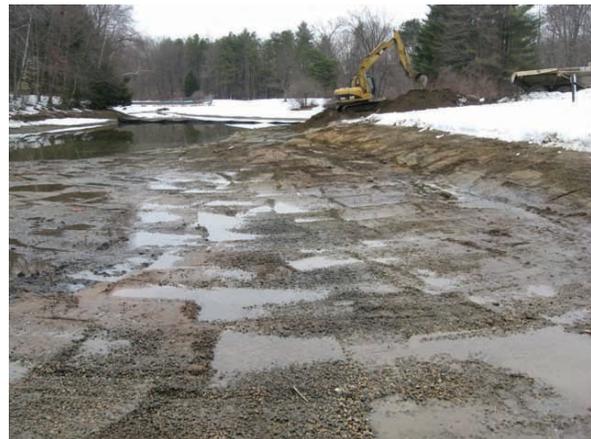
Dredging works as a plant control technique when either a light limitation is imposed through increased water depth or when enough soft sediment is removed to reveal a less hospitable substrate for plant growth (e.g. hard bottom or other nutrient-poor substrate). Light limitation through increased depth is possible in Warner's Pond, particularly since water clarity is already relatively poor. It may not be necessary to dredge the entire pond to achieve a satisfactory level of plant control, but it would be necessary to do a thorough job in any area where control is to be achieved or greater depths are desired.

Dredging in Warner's Pond could be an effective long-term control technique for nuisance aquatic plants within the targeted management area (Figure 14), but will be costly. The challenges of a project of this type are not unreasonable. The key factor influencing the approach and costs for moving forward with a dredge program at Warner's Pond will be the ability to draw down the pond to

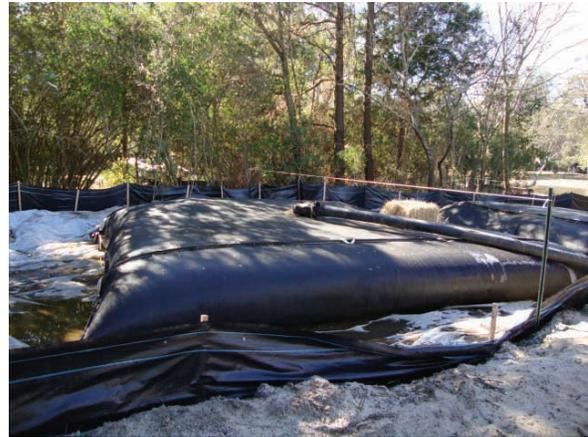
Geotubes used to dewater hydraulically dredged material

If conventional "dry" dredging is not determined to be feasible for Warner's Pond due to equipment access issues or water management concerns, hydraulic dredging would be a viable alternative. Hydraulic dredging is generally more expensive than conventional dredging for limited projects and it would require a larger and more sophisticated containment area to dewater the sediment as it is removed from the pond.
